Total Maximum Daily Load Development to Address a Benthic Impairment in the Little Calfpasture River, Rockbridge County, Virginia

Dr. Robert Brent
James Madison University

Virginia Department of Environmental Quality
JANUARY 2010

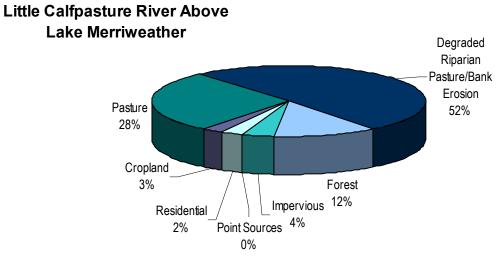
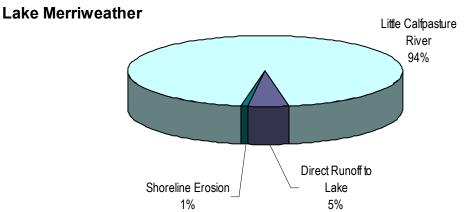
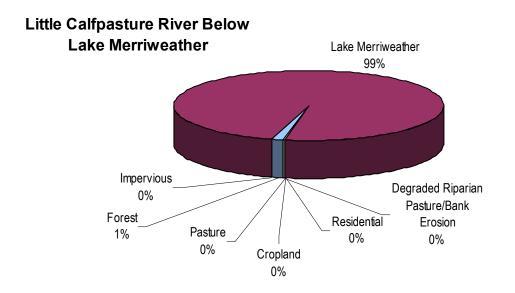
Figure 1-1. Sources of Sediment to the Little Calfpasture River.

Based on model results, approximately 3395 tonnes of sediment enter Lake Merriweather each year. The majority of this sediment comes from degraded riparian pasture, which is pasture land that is located along the river and its tributaries where cattle have access and where active bank erosion is occurring. While these areas account for only 2% of the land area in the watershed, they account for 52% of the sediment. Measureable amounts also come from upland pasture, cropland, forest, residential, and impervious areas (Figure 1-1). The sediment contribution to Lake Merriweather itself is primarily sourced from the Little Calfpasture River (94%). However, shoreline erosion also adds a measurable amount, as do the lakeside lands (5%). Below Lake Merriweather, almost all of the sediment in the Little Calfpasture River comes from the lake. This makes the lake a secondary source of sediment, passing through and resuspending sediment that had earlier entered the lake. The study found that the load of sediment discharged following a storm event was dependent upon the magnitude of the storm, but on average 76% of incoming sediment was transported downstream. The study also found that sediment discharge periods below the lake were more extended than above the lake, lasting up to 8 days following storm events. This extended duration of high solids events below the dam explains the observed pattern of solids in the Little Calfpasture River and a majority of the aquatic life impairment.

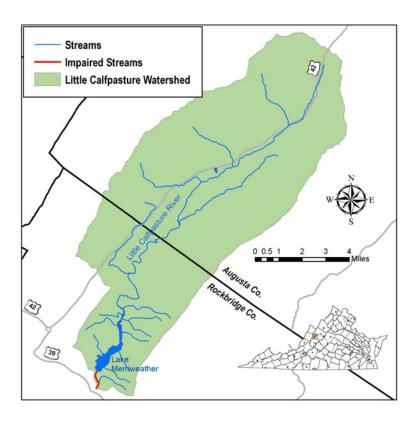
Figure 2-1. Location of Little Calfpasture River.

The Little Calfpasture River was first assessed as impaired and listed on the 303(d) list in 1996. The impaired segment is a 0.83 mile reach from the Goshen Dam to the confluence with the Calfpasture River (shown in red on Figure 2-1). This reach fails to meet the general standard for aquatic life based on biomonitoring of the benthic macroinvertebrate community. This aquatic life impairment has continued, and this section of the Little Calfpasture River (Assessment Unit ID: VAV-I32R_LCF01A00) has remained on the 303(d) list from 1996 through the most current 2008 305(b)/303(d) Integrated Report (VADEQ, 2008).

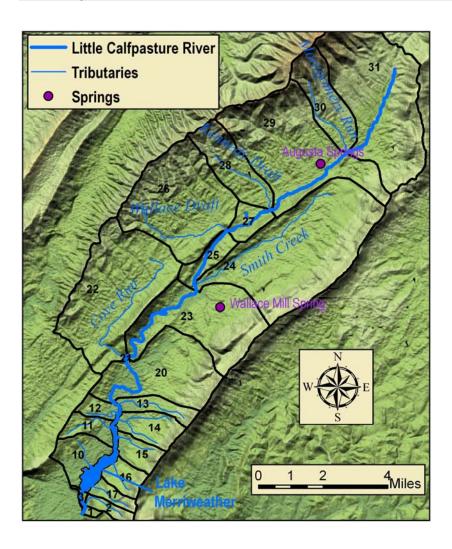
Figure 3-1. Little Calfpasture River Sub-watersheds and Tributaries.

The Little Calfpasture River watershed is located in Augusta and Rockbridge Counties, Virginia (Figure 2-1). The Little Calfpasture River flows south from its headwaters in Augusta County into Rockbridge County within a narrow valley between Great North Mountain to the west and Little North Mountain to the east (Figure 3-1). The Little Calfpasture River is 22.3 miles in length and receives flow from perennial tributaries, intermittent tributaries, and springs. Named perennial tributaries within the Little Calfpasture River watershed include Montgomery Run, Kennedy Draft, Wallace Draft, Smith Creek, and Cove Run. Significant springs include Augusta Springs, which serves as a water source for Augusta County, and Wallace Mill Spring, which serves the Castaline Trout Farm. The most notable water resource in the Little Calfpasture River watershed is Lake Merriweather. Lake Merriweather is a 444-acre manmade impoundment formed by the Goshen Dam, which is located approximately 0.8 miles upstream from the watershed outlet. To assist in modeling the hydrology of the Little Calfpasture River the watershed was divided into 23 sub-watersheds (Figure 3-1).

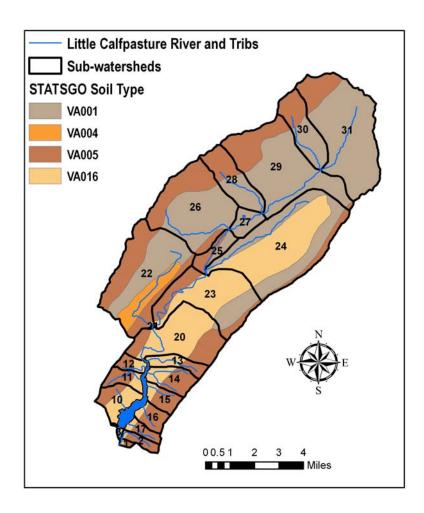
Figure 3-3. Soil Types in the Little Calfpasture River Watershed.

Soils data for the Little Calfpasture River watershed were obtained from the U.S. General Soil Map (STATSGO) database (NRCS, 2006) and are shown in Figure 3-3. The predominant soils in the Little Calfpasture River watershed are the Berks-Weikert-Laidig series (VA001). These soils are found throughout most of the northern Little Calfpasture River valley. These soils are shallow to very deep and are well drained. They are loamy and weathered from shale, siltstone, and fine-grained sandstone. Permeability in these soils is moderate to moderately rapid. These soils are in hydrologic soil group C.

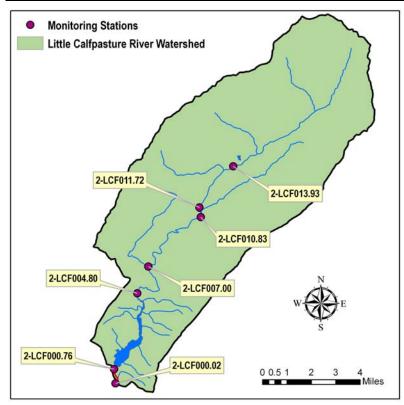
Figure 4-1. Monitoring Stations on the Little Calfpasture River.

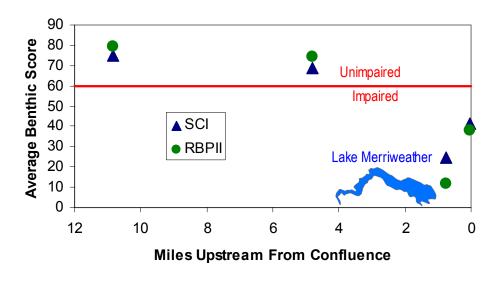
Figure 4-2. Average Benthic Assessment Scores for Little Calfpasture River Stations.

Benthic assessments have been conducted approximately 6 miles upstream of Lake Merriweather (2-LCF010.83), directly upstream of Lake Merriweather (2-LCF004.80), directly downstream of Lake Merriweather (2-LCF000.76), and further downstream near the mouth of the Little Calfpasture River (2-LCF000.02). The average Stream Condition Index (SCI) scores and average RBPII scores for each of these stations are shown in Figure 4-2. At both stations upstream of Lake Merriweather, average SCI scores are in the non-impaired range (above 60) and RBPII scores are in the slightly impaired region (54 to 79), which is assessed as meeting the aquatic life use. At both stations below Lake Merriweather, SCI scores are in the impaired range (below 60) and RBPII scores are in the moderately or severely impaired region, which is assessed as not meeting the aquatic life use. Benthic scores are lowest directly below the Goshen Dam, with SCI scores averaging 24 and RBPII scores in the severely impaired region (12). Benthic scores improve to moderately impaired as distance from the dam increases.

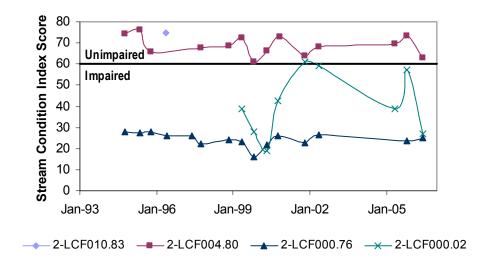
Figure 4-3. Stream Condition Index Scores Over Time in the Little Calfpasture River.

The historic time series of benthic monitoring shows that directly below Lake Merriweather (at Station 2-LCF000.76), conditions are consistently very poor and not likely to improve regardless of operational practices at the dam. At the mouth of the Little Calfpasture River, however, historic benthic monitoring shows that attainment of the aquatic life standard is possible. The SCI score in Fall 2001 was in the unimpaired range. This was during a time period when the dam was being operated in accordance with the DEQ Consent Order and significant lake lowerings had not been conducted for a period of 24 months prior to the benthic sample. This aquatic life score and others close to the unimpaired range in Spring 2002 and Fall 2005 show that attainment of the aquatic life standard is possible at the mouth of the Little Calfpasture River.

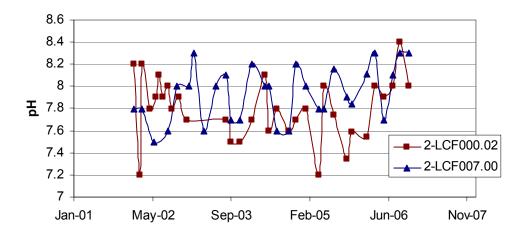
Figure 4-11. pH in the Little Calfpasture River.

The cause of the small but statistically significant decrease in pH could be due to changes in water chemistry within the lake, or it could simply be an artifact of sampling times. On each sampling date, samples were collected from station 2-LCF000.02 before station 2-LCF007.00. Because of the daily pattern of surface water pH, which rises throughout the daylight hours, earlier collected samples would systematically be lower in pH. This diurnal pattern in pH is due to photosynthesizing algae consuming CO₂ during the day. Because CO₂ is slightly acidic, its removal from the water column increases pH during the daylight hours. At nighttime when photosynthesis ceases, respiration exceeds photosynthesis, and CO₂ is produced by aquatic life, lowering the pH. Samples from station 2-LCF000.02 were on average collected about an hour and a half prior to samples from station 2-LCF007.00. This difference could explain the lower pH values at station 2-LCF000.02.

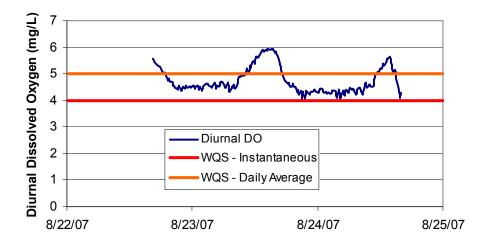
Figure 4-16. Diurnal Dissolved Oxygen Pattern in the Little Calfpasture River in August 2007.

To confirm low summer oxygen levels at station LCF000.02, VADEQ again conducted diurnal dissolved oxygen monitoring for a 5-day period in late August, 2007. Monitoring equipment was deployed at station 2-LCF000.02 from 8/22/07 through 8/27/07, however, the dissolved oxygen probe fouled on 8/24/07 and reliable data were only obtained for 3 days. During this 3-day period, dissolved oxygen levels did not violate the instantaneous water quality standard of 4 mg/L (Figure 4-16). The daily average criterion, however, was violated on each of the three days. Dissolved oxygen averaged 4.8, 4.8, and 4.6 mg/L on the 3 days, respectively.

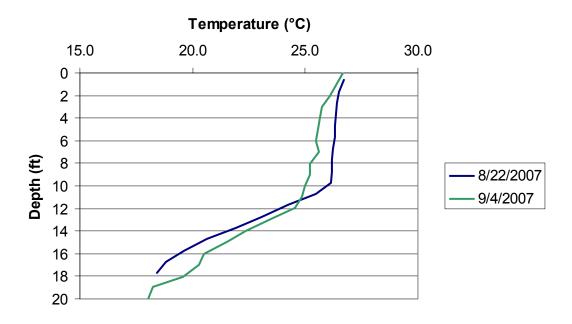
Figure 4-17. Temperature Profile With Depth in Lake Merriweather.

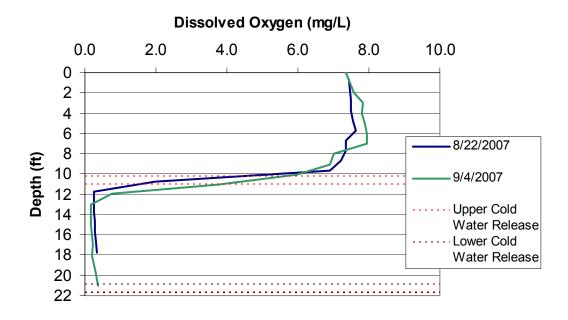
Figure 4-18. Dissolved Oxygen Profile With Depth in Lake Merriweather.

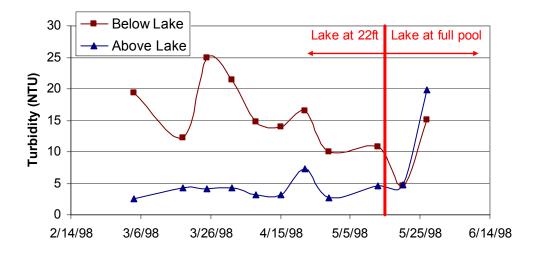
Figure 4-22. Results of VADGIF Turbidity Study on the Little Calfpasture River in 1998.

The other obvious trend in the data is the correlation with dam operations. During the majority of the turbidity study, Lake Merriweather was maintained below full pool at 22 ft. On March 15, 1998, the Lake was raised to the 26 ft full pool mark. All of the nine turbidity measurements taken while the lake was below full pool showed much higher turbidity downstream. Turbidity averaged 4 NTU upstream and 16 NTU downstream. This is a 4-fold increase in turbidity below the lake. After the lake was raised to full pool on March 15, 1998, turbidity measurements were lower below the lake. This demonstrates the significant impact of lake lowering on sediment transport downstream. It also supports the last two scenarios identified above: that lake lowering increases shoreline erosion, and lake lowering increases mixing within the lake to resuspend settled particles.

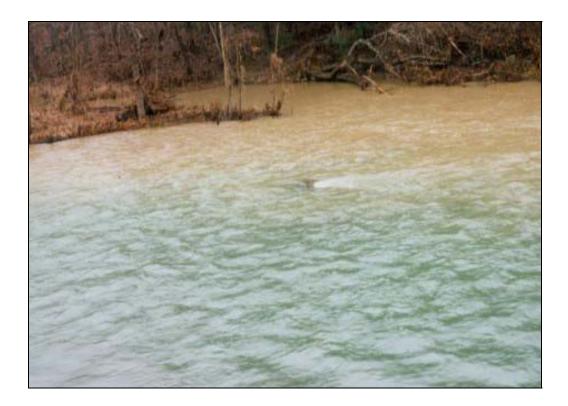
Figure 4-32. View of Sediment Discharging from the Little Calfpasture River into the Maury River.

Multiple lines of evidence also suggest that sediment is a most probable stressor of the benthic community within the impaired reach. The first line of evidence is historical documentation that includes Notices of Violation, Consent Orders, and numerous investigations and complaints. All of this documentation points to the periodic release of large amounts of sediment from the lake. VADEQ enforcement files include pictures (Figure 4-32) and descriptions of intense sediment loads coming through the dam and continuing downstream into the Maury River. Enforcement files have documented the periodic release of sediment during lake drawdown, and more sustained sediment releases during time periods when the lake was below full pool and exposed shorelines were eroded by storm events. The Consent Orders were intended to address these problems by requiring the Boy Scouts to develop protocols for dam operation that keep the lake at full pool (except under anticipated flood conditions) and eliminate the use of subsurface discharges for drawing down the lake. However, compliance with these Consent Orders has not been consistent, and there is still the periodic need to lower lake levels during flood events and for maintenance.

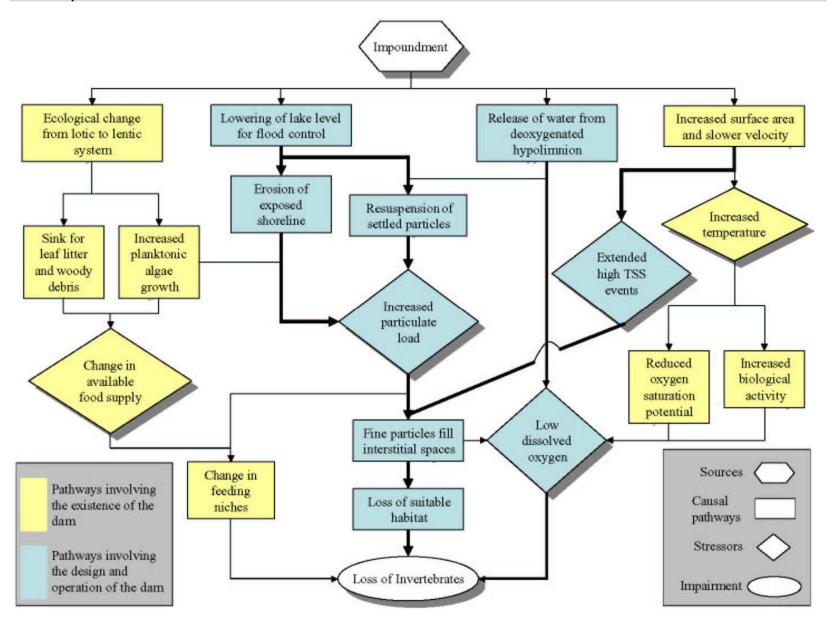
Figure 4-34. Conceptual Model for the Cause of Impairment in the Little Calfpasture River.

In Figure 4-34, the width of the connecting arrows was designed to symbolize the strength of the individual causal pathways. For instance, the widest connecting arrows flow through the pathway of increased sediment and particulates. It is likely that this causal pathway has the most influence on the loss of invertebrates and the benthic impairment. The second strongest influence on the benthic community is likely through the pathway of low dissolved oxygen. Lastly, changes in the available food supply and feeding niches is likely the least important of the causal pathways, but still exerts an impact on the benthic community.

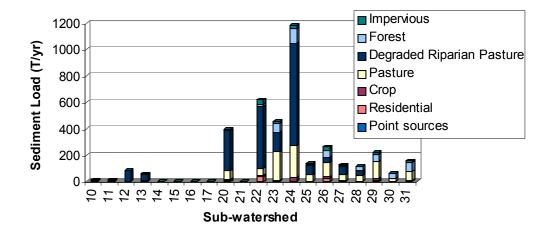
Figure 5-4. Sediment Loads in Little Calfpasture River Sub-watersheds Above Lake Merriweather.

Sediment loadings were also calculated for each sub-watershed. The largest sediment loading was from sub-watershed 24, which covers the Estaline Valley and is drained by Smith Creek. Sediment loads from this watershed averaged 1184 T/yr, which is more than 10 times the load of most sub-watersheds and nearly twice as high as the next highest sub-watershed. This is not surprising since sub-watershed 24 contains the most acres of pasture and degraded riparian pasture of any sub-watershed. The second highest sediment load is from sub-watershed 22, which contains the most impervious area of any sub-watershed and the second most degraded riparian pasture and pasture acres. Sub-watersheds 20 and 23 were the next highest contributors of sediment loads. These top 4 sub-watersheds in sediment contribution are also some of the largest sub-watersheds, so loads are expected to be higher than in smaller sub-watersheds. Figure 5-5 shows sub-watershed sediment contributions on a unit area basis (i.e., sediment load per acre). On this basis, an area on the north end of Lake Merriweather, an area just north of Craigsville, and Estaline Valley have the highest unit area sediment loads.

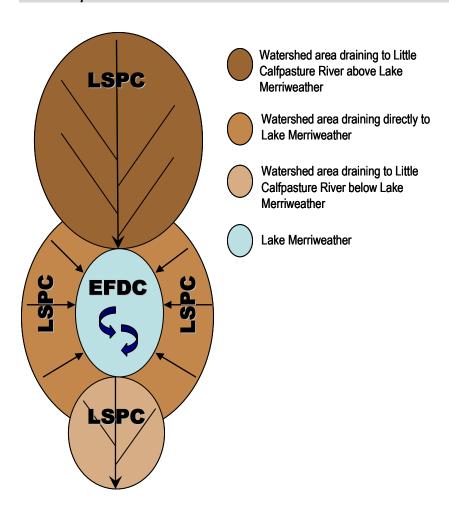
Figure 6-1. Integration of LSPC and EFDC Models in the Little Calfpasture River Sediment TMDL.

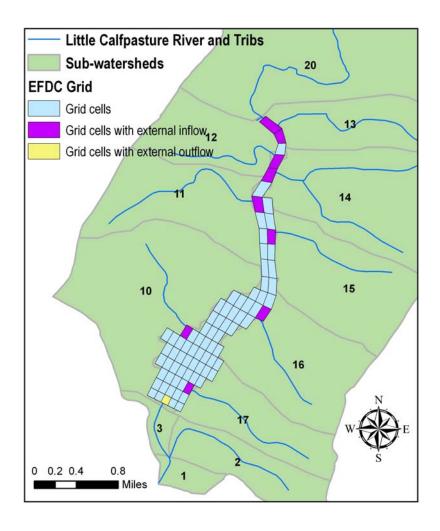
Figure 6-3. EFDC Model Grid of Lake Merriweather.

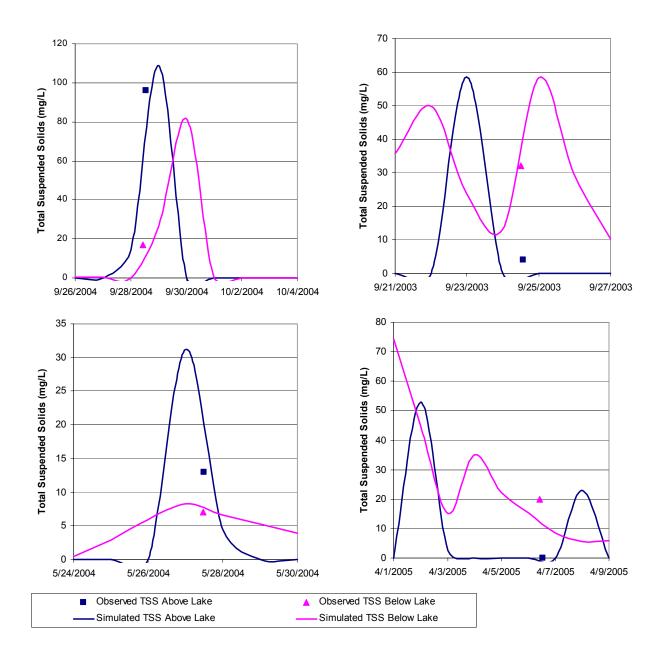
Figure 6-24. Comparison of Observed and Simulated Total Suspended Sediment Concentrations During Individual Storm Events.

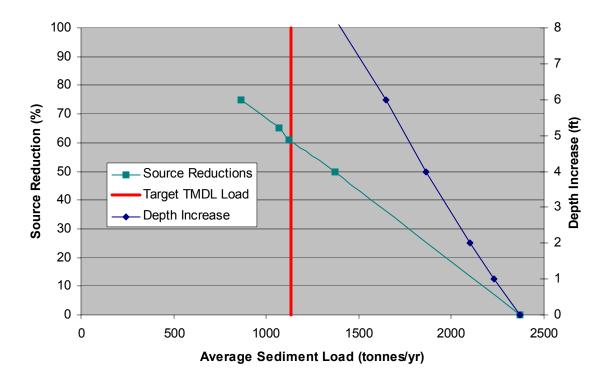
Figure 7-9. Impact of Sediment Source Reductions and Lake Sediment Management Options on Average Sediment Loads at the Mouth of the Little Calfpasture River.

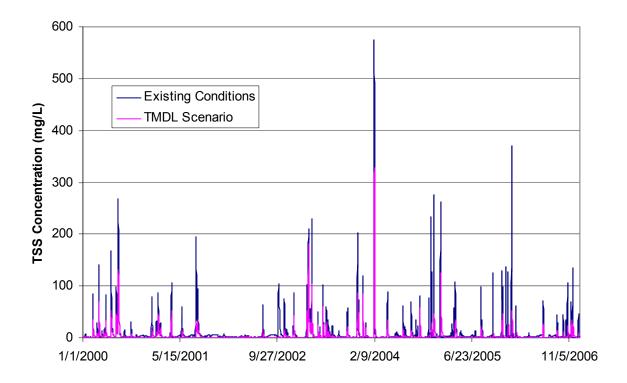
Figure 7-12. Total Suspended Solids Concentration at Mouth of the Little Calfpasture River Under Existing Conditions and TMDL Scenario.
